The Church of St. Mary in Oslo – Overview and Revision of the Building History

MORTEN STIGE & PETTER SNEKKESTAD

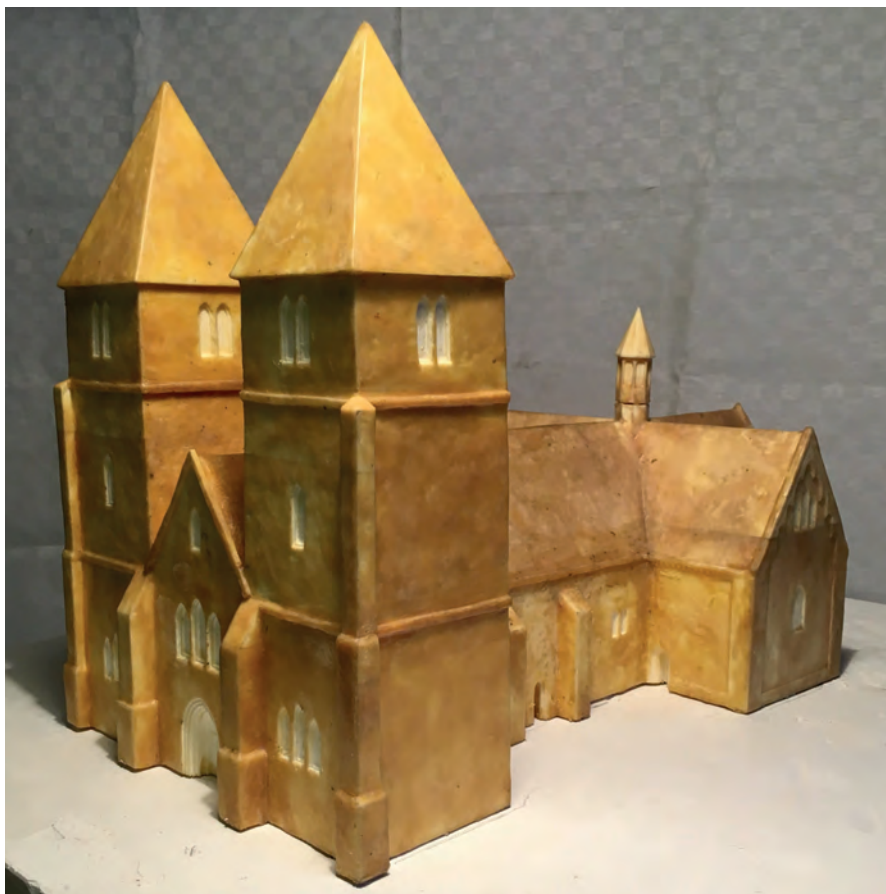
Fig. 1. Hypothetical reconstruction of St Mary's in Oslo c. 1300. The height of the towers and the width of the west front corresponds. Brickwork is limited to the chancel extension. Model by Karen Maria Eiken-Engelgård and Terje Berner after design by Stige and Snekkestad.

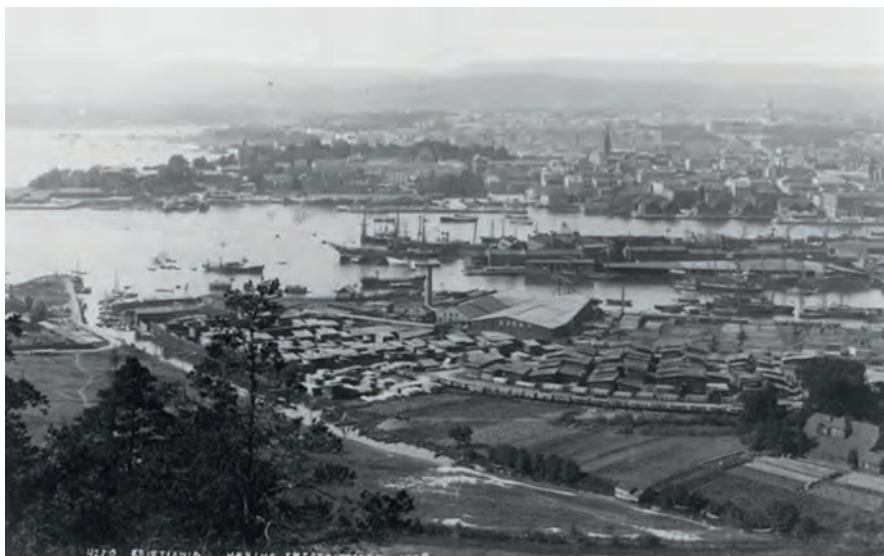
Fig. 3. The area of Sørenga, Gamle Oslo in 1909, looking westwards. The ruin of St. Mary's was found just north and partly underneath the barn seen in the lower right corner. Photo: Ragnvald Væring, Oslo Museum.

After being informed by a local landowner who had found mural remains beneath his barn, antiquarian Nicolay Nicolaysen began the first excavation of the site in 1868. He quickly identified it as the royal chapel dedicated to St. Mary and the results were published in *Fortidsminneforeningens Journal* for 1869 (Nicolaysen 1871). Nicolaysen's efficient dig did not comprise the whole ruin, yet allowed for a ground plan drawing by architect Christian Christie with only few inaccuracies.² Apart from doc-

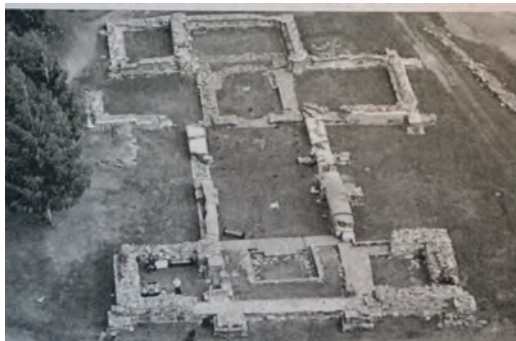
Fig. 4. Aerial view of the ruin of St. Mary's after Håkon Christie's conservation work in 1971.

Save for the sacristy and chapel, the ruin finally underwent conservation from 1961–1963. Some years later, in 1969 and 1971, the Romanesque west wall and tower were reconstructed to one course height in places where only foundations had survived. Although the principal conservation techniques were documented, a description of secondary material added to the Medieval Period masonry is missing. Consequently, it is not always clear which courses are authentic, and whether secondarily applied building stone was found on-site or not.⁸ Moreover, the masonry character has in places been altered, through straightening out “sinking” courses, changing the position of individual stones and applying too fat joints. These misrepresentations are mostly found in the western part of the nave, where Fischer chiselled out joints. Considering how the masonry character of St. Mary's, especially the Romanesque masonry of the nave, has been the object of scholarly study and comparison with other churches, it is necessary to be aware of how and where conservation work changed its look.

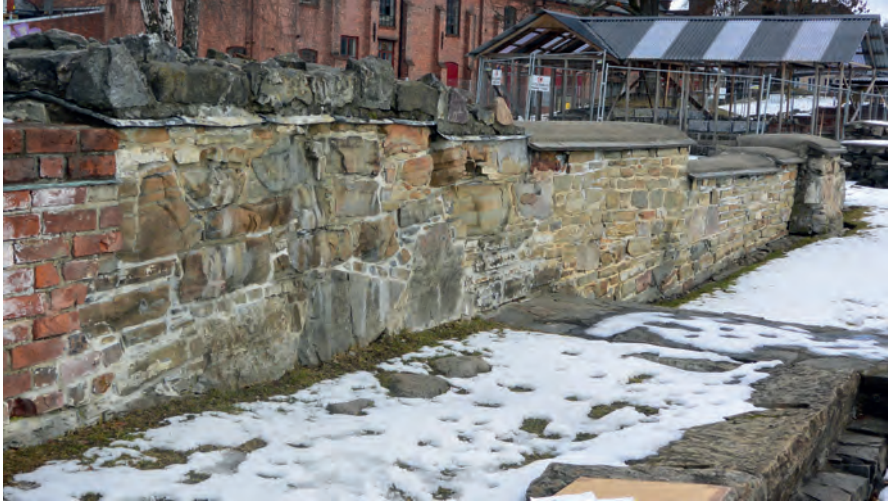
Fig. 8. Inner, northern wall of the nave displaying three periods of building. The Romanesque masonry to the right is cut and extended westwards by the Gothic elongation of the nave. Lastly, a later rebuilding in brick of the opening to the northern tower is seen to the left. Photo: Morten Stige.

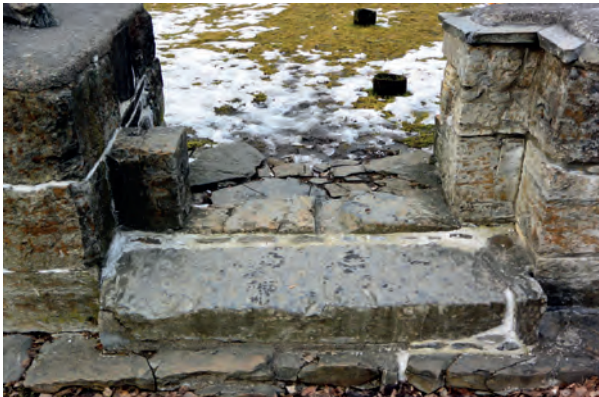
Fig. 9. The southern portal of the nave is the best preserved element of the Romanesque church. The portal is fitted with orthocer limestone. Photo: Morten Stige.

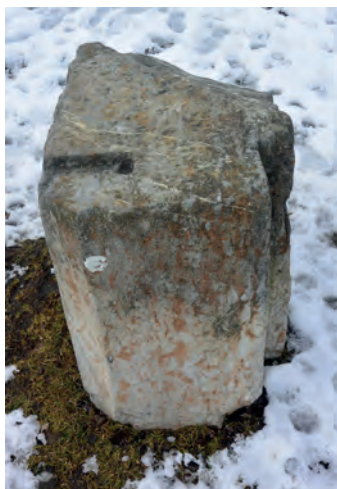
Fig. 10. The finely hewed block of orthocer limestone probably belonged to the southern jamb of the Romanesque church's west portal. Photo: Morten Stige.

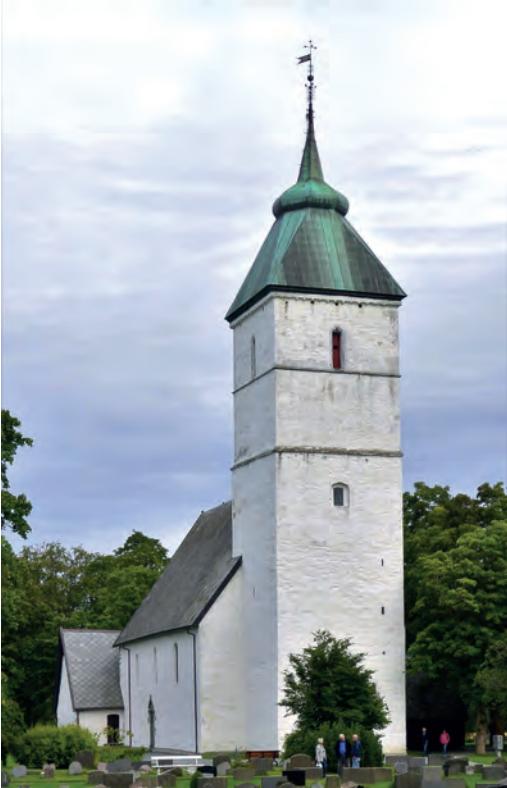
Fig. 11. Værnes church, Nord-Trøndelag is an illustration of the possible scale of the Romanesque St. Mary's and shows the imposing effect of the western tower. Photo: Morten Stige.

Finally, in attempting to recreate the Romanesque church's elevation, Værnes Church in Trøndelag (c. 1130-1195) can serve as a guiding parallel. The nave is 34 m long and 14 m wide which is similar to St. Mary's measurements excluding the towers. The nave's walls are 9 m high with a gable of 18 m. The use of Værnes as a model for a reconstruction of the volume of St. Mary's does not imply that we see it as a likely model for St. Mary's. We are aware of the regional stylistic differences between Trøndelag and Eastern Norway. Churches in Trøndelag of the period are generally more high-raised and exhibit steeper gables than the Eastern Norwegian ones (Lidén 1981). Yet, notable exceptions in parish churches in the district suggest that a similar height in a high-status church like St. Mary's is likely.¹⁷ Værnes' roof angle of 55 degrees is also slightly steeper than the average in Eastern Norway (Storsletten 2002). Again,

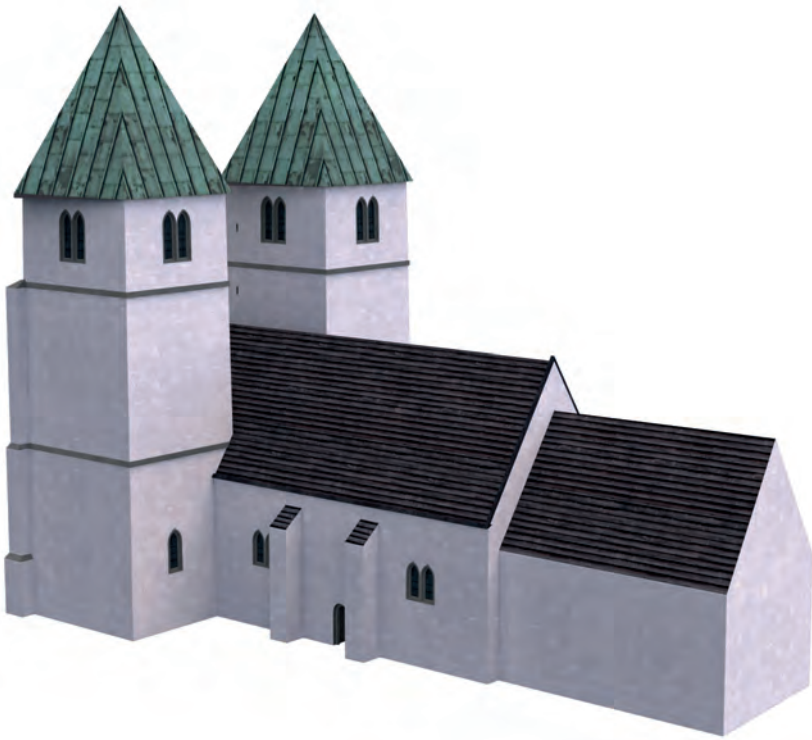
Fig. 12. Hypothetical reconstruction of St. Mary's 1220–1280, with the Early Gothic chancel and the extended west front. Model by Karen Maria Eiken-Engelgård after design by Stige and Snekkestad.

At some point the chancel was elongated, the apse being replaced by a right-angled east end. The original chancel covered a net surface of 57 m² (Eide 2015: 249). After the extension it measured c. 83 m². This makes the addition a 45% increase of the floor space. Chancel extensions became common in the thirteenth century and all our cathedrals had modern Gothic chancels by ca 1300 (Stige 1997: 197). The reasons could have been both liturgical and functional. It has been argued that the reference to the teaching of transubstantiation at the fourth Lateran council of 1215 gave new importance to the communion and thus larger choir space. For the cathedrals we presume that a larger clergy was the main driving force. This may also have been the case for St. Mary's.

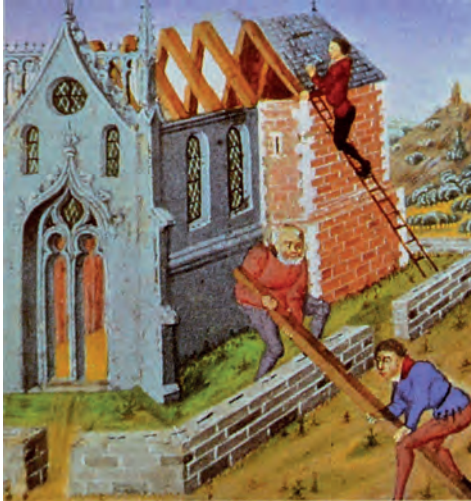
Fig. 13. A building design where a brick volume has been added to a volume of dressed stone. Marginal miniature from the Girart-de-Roussillion manuscript (1448) in the National Library in Vienna. (After Jan Svanberg, *Master Masons*. Stockholm 1983: 75.)

It can be argued, as have most authors, that the eastern and the western extensions belong together as they provide an architectural balance to the church. The clear evidence of brick in the east then suggests a similar material choice in the west. This is a sound point, but many surviving churches demonstrate that building projects did not always go according to plan. The two parts may thus have been built with a considerable distance in time and with different materials and design. We can often ob-

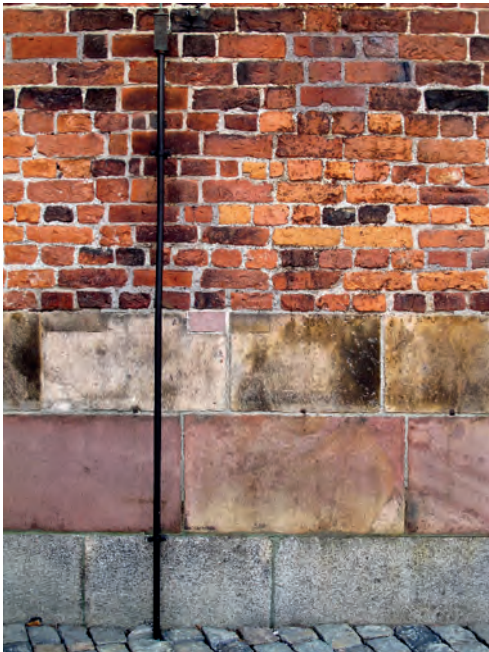
Fig. 14. Detail from the north wall of Riddarholmskyrkan, Stockholm shows how the brickwork starts above three courses of ash-lars. Photo: Morten Stige.

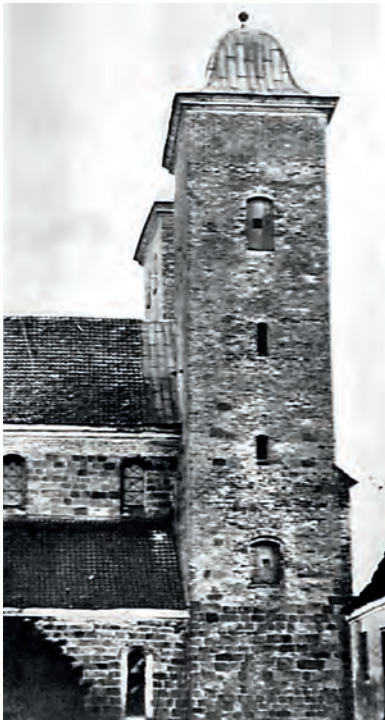
Fig. 15. Viborg Cathedral, Jutland in 1863 before restoration. The first storey of the western part in dressed stone has been heightened to towers in brickwork. Photo: Rye. (After Vellev 1976: 18.)

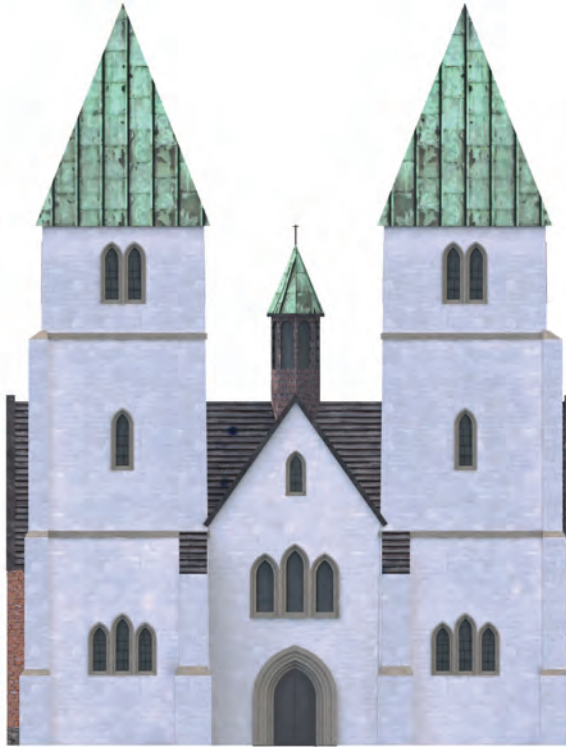
Fig. 16. Hypothetical reconstruction of St. Mary's with the extended west front. Model by Karen Maria Eiken-Engelgård after design by Stige and Snekkestad.

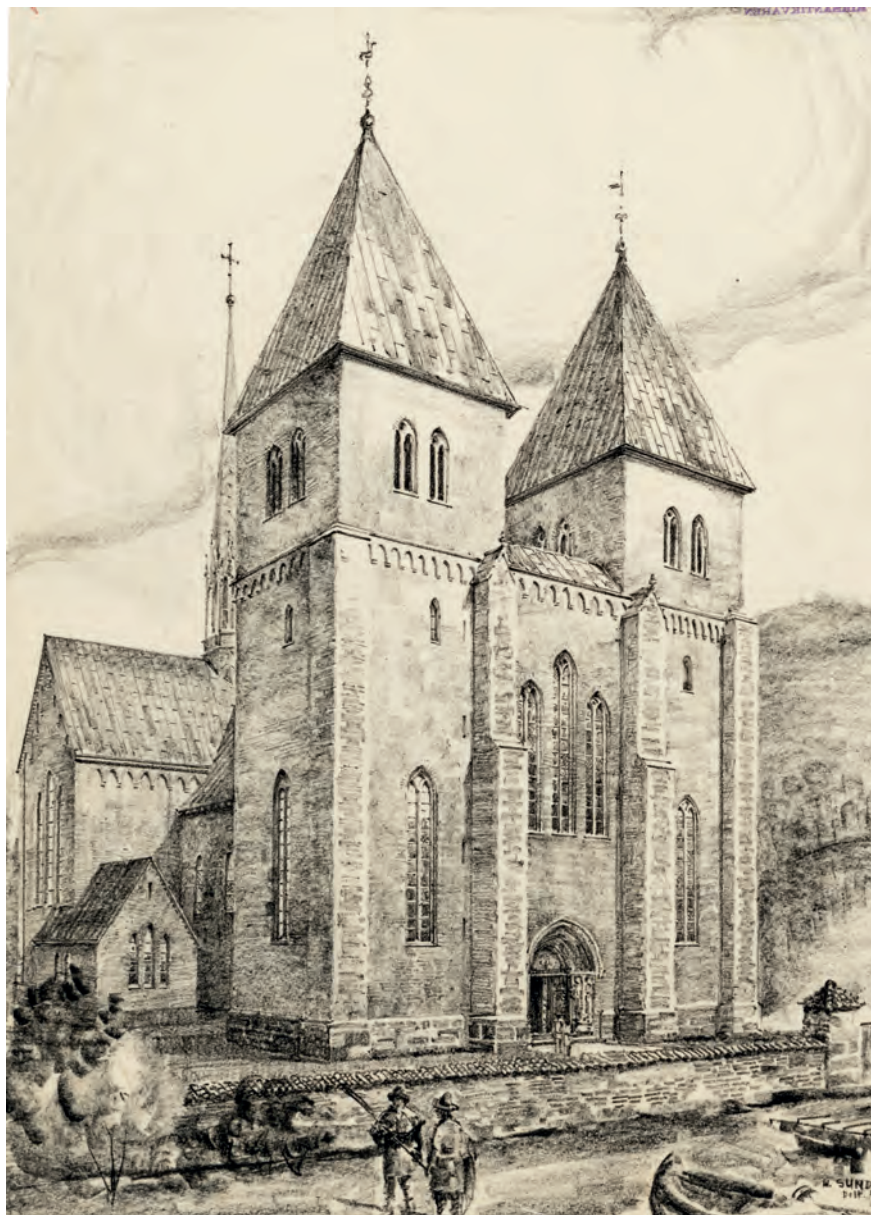
Fig. 17. Reconstruction drawing of St. Mary's by Harald Sund (1935) with early Gothic screen front. Archive of the Directorate for Cultural Heritage.

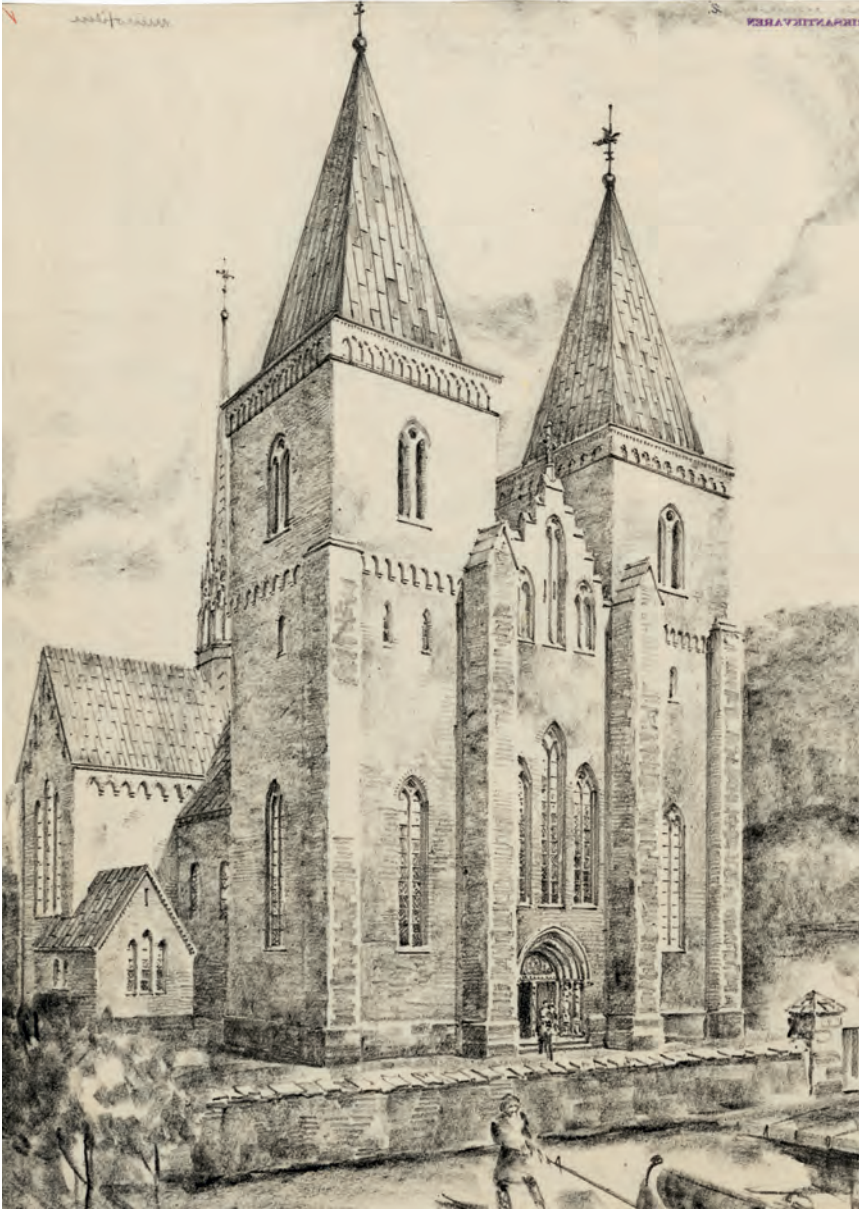
Fig. 18. Reconstruction drawing of St. Mary's by Harald Sund (1935) inspired by Roskilde Cathedral. Archive of the Directorate for Cultural Heritage.

²⁵ Roskilde was used as a model for the reconstruction (Fischer 1950b: 83). However, the idea of Roskilde as a medieval inspiration, was discarded already by Horgen. See Horgen 1995: 111.

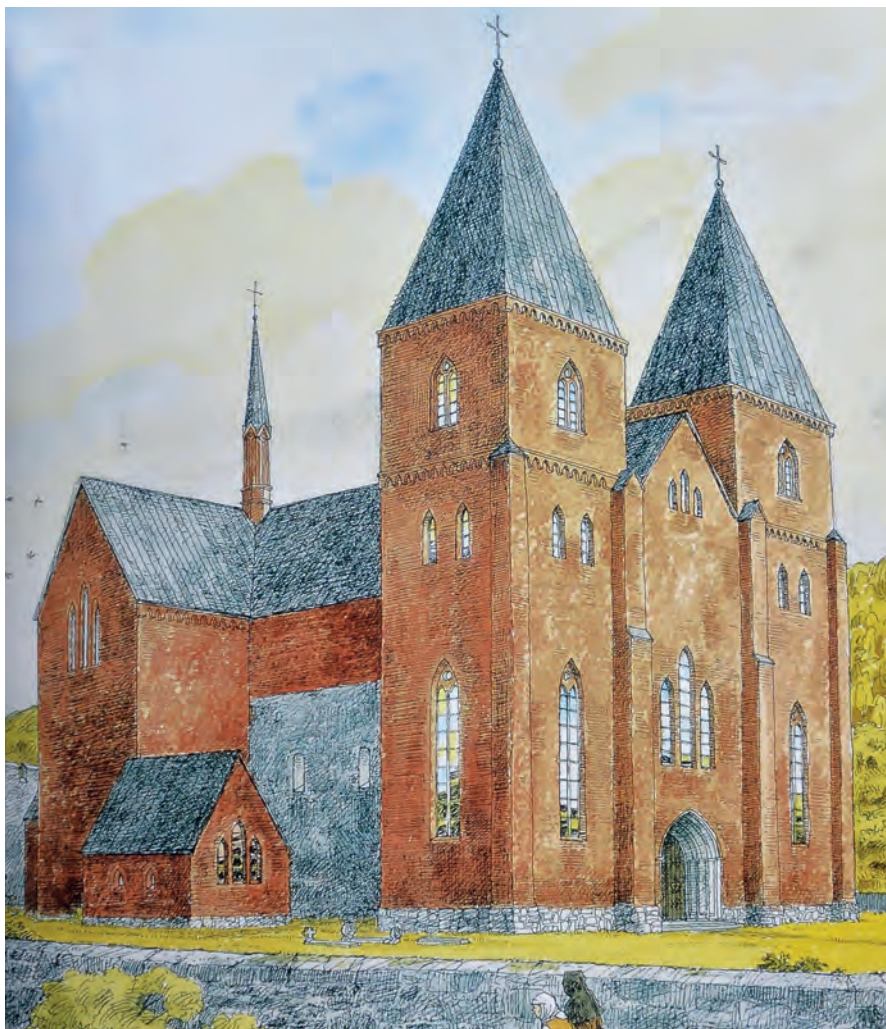
Fig. 19. Reconstruction drawing of St. Mary's by Erik Schia and Karl-Fredrik Keller inspired by Roskilde cathedral. (After Keller & Schia 1994: 29.)

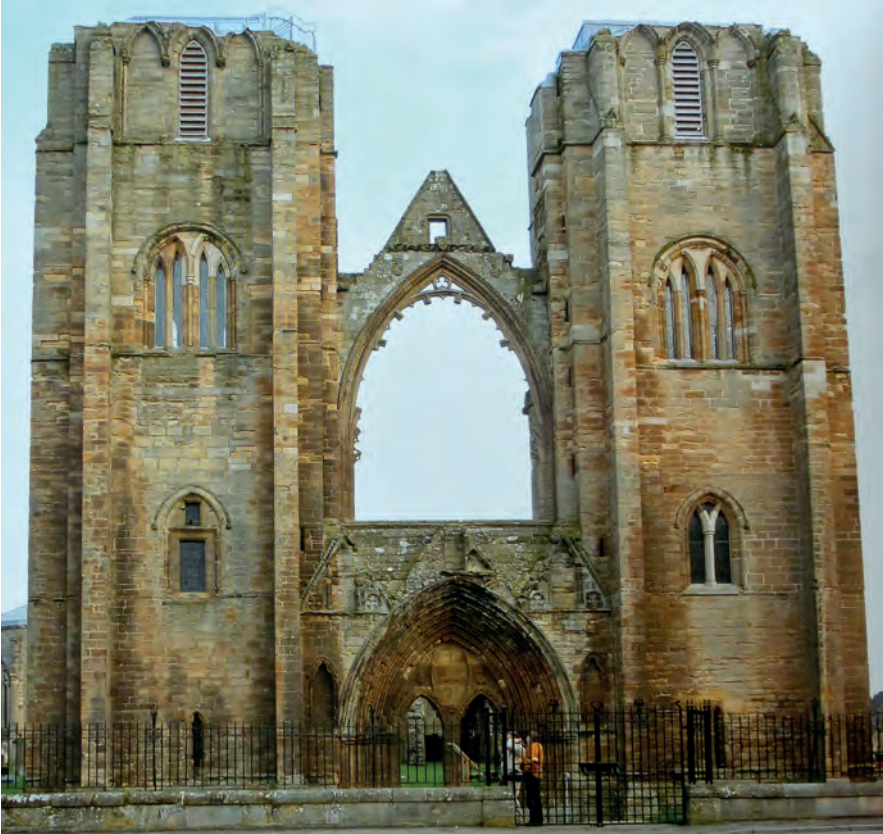
Fig. 20. The two tower west front of Elgin Cathedral, Scotland (1224–1280). Photo: Richard Fawcett. (After Fawcett 2011: 134.)

the fact that all major town churches from the period are lost. As St. Mary's had a royal patron, we presume the west front was built in Early English with grouped lancet windows and blind arches.

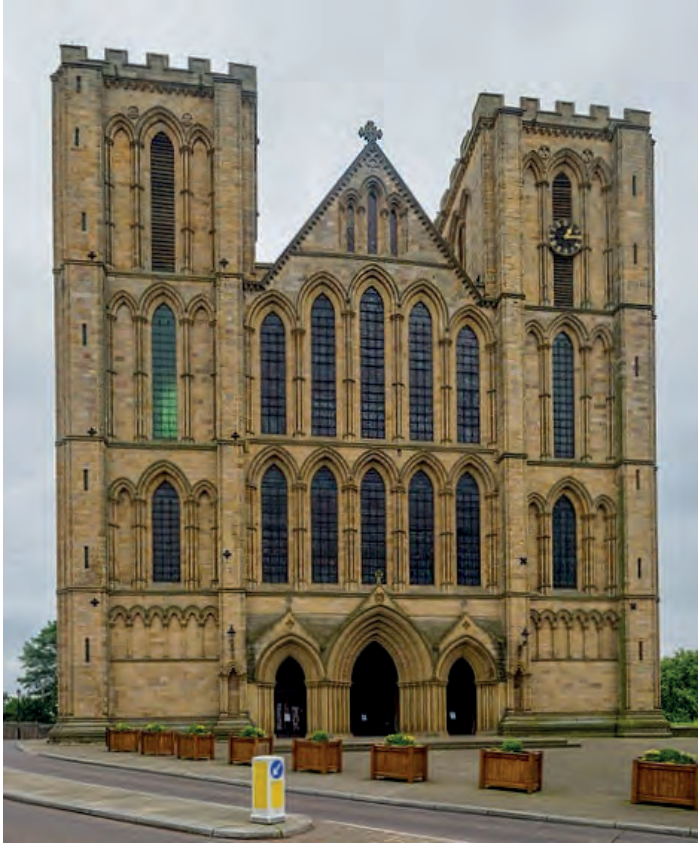
Fig. 21. The two tower west front of Ripon Cathedral, North Yorkshire (c.1220). Photo: Diliff (http://www.wikiwand.com/en/Ripon_Cathedral, License: Creative Commons Attribution-Share Alike 3.0)

Ripon Cathedral near Leeds has an Early English west front with twin towers and the exact same width as St. Mary's. The nave is much higher and wider than in Oslo, but the detailing of the wall and the windows are relevant. The west front was added c. 1220. A marginal monument like Elgin Cathedral, the northernmost of mainland Scotland, gives an impression of how the volumes of the west façade might have

looked. It was begun 1224 and finished c. 1280 and is 27 m wide, yet behind the façade it is a basilica (Fawcett 2011: 128–135). Nothing like St. Mary's is likely to be found in more central parts of Europe: A major royal church with a single-aisled nave in the thirteenth century was inconceivable elsewhere. However, styles and features were in general influenced by the international developments. A single monument was never copied, but each church was created as a unique combination of borrowed and original features.

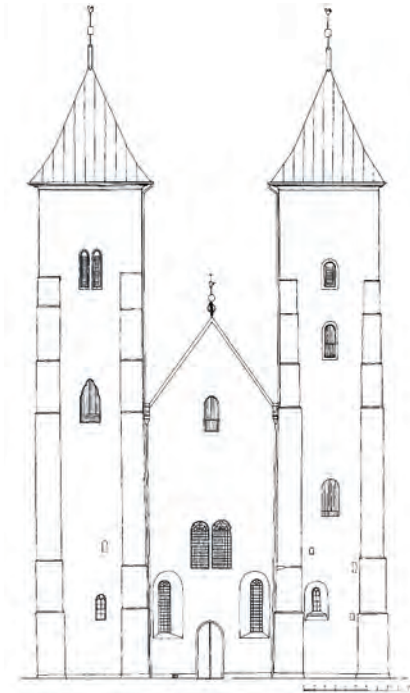
Fig. 22. The two-tower west front of St. Mary's, Bergen by Knut Skjeggstad. (After Lidén og Magerøy: *Norges kirker. Bergen vol 1*. 1980: plate 3.)

In Norway, the Romanesque west façades of St. Mary's in Bergen and Hamar Cathedral were possible inspirations close at hand. The eastern front of Stavanger Cathedral (1272–1300) is later, but still serves as an interesting parallel, demonstrating an original way of composing a representative façade with simple means. Like the two Romanesque churches it has twin towers. These façades are only 20,5, 20,0 and 19,5 m wide respectively, yet they express the same concept as St. Mary's with its 31,4 m. The Gothic western volume in Stavanger has the same wall dimensions as St. Mary's and a width of 10,8 m, which is similar to each of the bays in Oslo. The height of 19,5 m to the top of the gable is also relevant as a reference as to the possible elevation of St. Mary's.

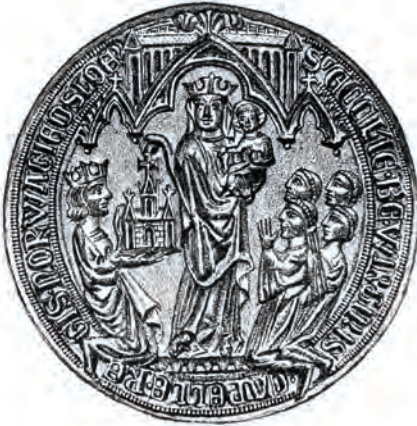
Fig. 24. The seal of St. Mary's showing a church model with a twin towers west front and an additional central tower. (After Nicolaysen 1870: plate V.)

gable, the illusion would be complete. St. Mary's seal is here relevant. One must be extremely careful in regarding seals as architectural evidence, but taking the seal of St. Mary's c. 1300 at face value, it shows a screen front with two flanking towers and a central tower behind.

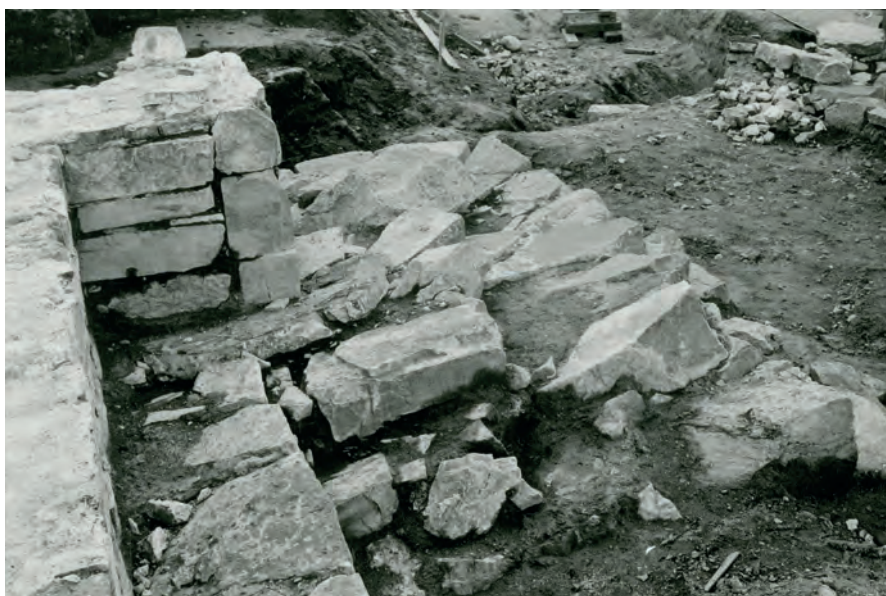
Fig. 25. The foundations under the Southwestern corner of the western tower show considerable settling stemming from the weight of the tower. Photo: Gerhard Fischer (<http://kulturminnebilder.ra.no>).

²¹ For a description of foundations, see Fischer 1935: 36, 51. Beneath the northern wall of the north tower, instead of vertical piles, rows of thin timber were laid horizontally under the stone foundation. The tilting of the foundations under the southern buttress shows that the

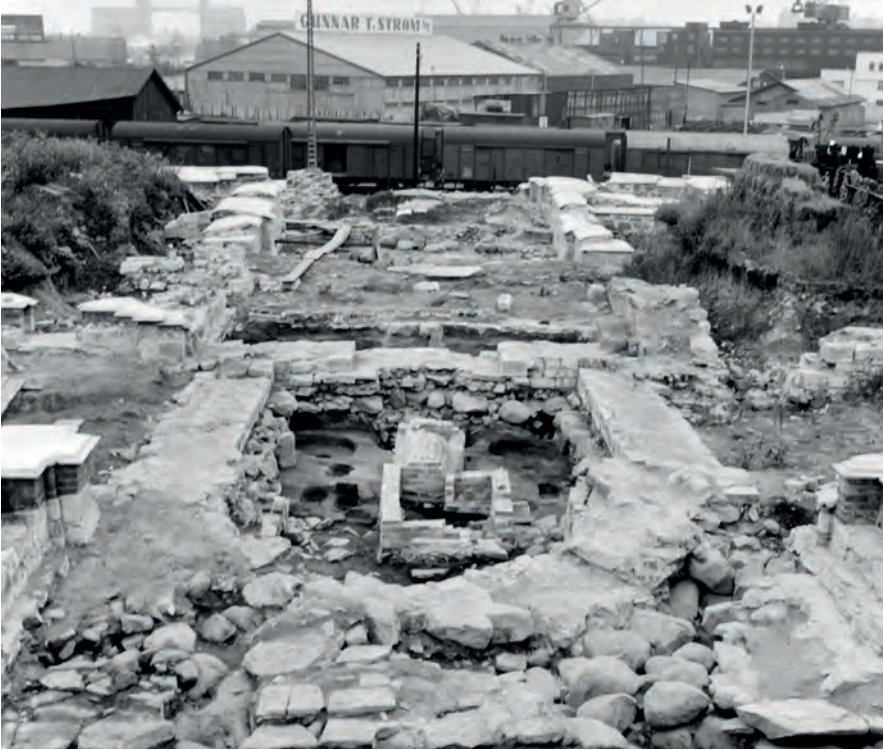
Fig. 26. The excavated ruin of St. Mary's seen from the East. The brick burial chambers of King Håkon Magnusson, Queen Eufemia and Prince Wizlaw are exposed in the crossing. Photo: Håkon Christie (1961) (<http://kulturminnebilder.ra.no>).

That the double grave vaulting in brick, centrally located in the crossing, did indeed belong to King Håkon and his Queen Eufemia, is well documented and has been the general opinion since an article by Gustav Storm in 1877 (Storm 1877: 468; Storm 1892: 416–424; Holck 1975: 149–168). He also argued for the grave of King Håkon VI being a «much damaged burial» to the south east of the double grave (Storm 1892: 421–422). Circumstantial evidence makes this conclusion reasonable.

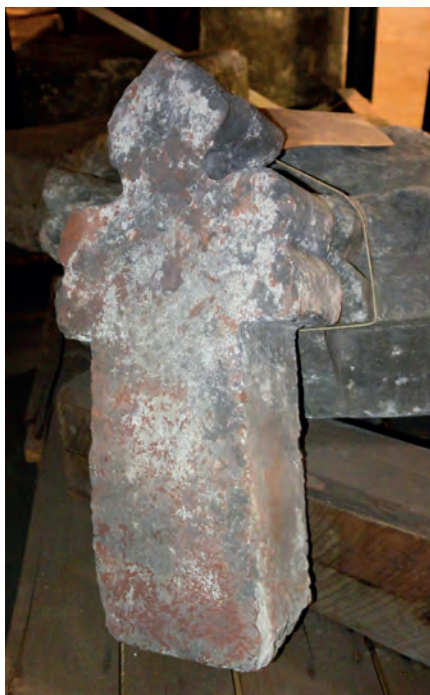
Fig. 28. Lime stone boss found in the ruin of St. Mary's, fitted with one of the brick ribs. Probably from the crossing. Collection of The Museum of Cultural History, University of Oslo. Photo: Morten Stige.

The excavations unearthed a number of moulded brick fragments that together with preserved remains of slender responds in the corners of the chancel, suggest that all four space units in the east were covered by rib vaults. Brick ribs with the same profile as the ribs of St. Mary's were also found in the cross shaped chancel at Hovedøya Abbey which was probably completed at the end of the thirteenth century.²⁷ Hence one of the closest parallels to the Romanesque St. Mary's also got a Gothic chancel with the same layout and vaulting.

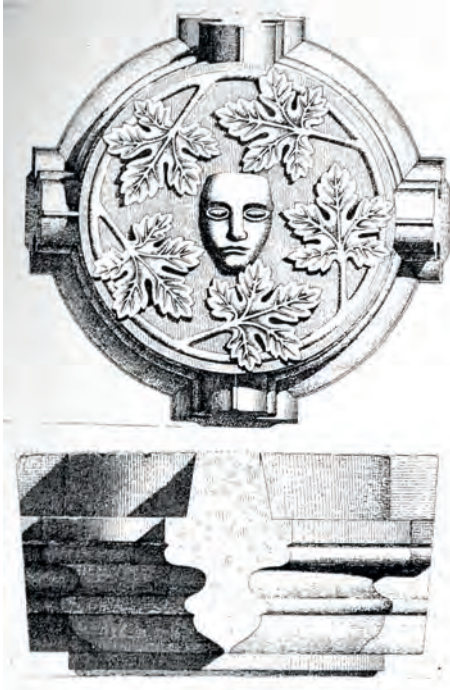
Fig. 29. The boss from the Abbey church at Hovedøya has the same rib profile as the chancel vaults of St. Mary's and gives an indication of the style of the lost and damaged bosses. Drawing by Nebelong (1849). (After Nicolaysen, *Hovedø kloster og dets ruiner*. Kristiania, 1891.)

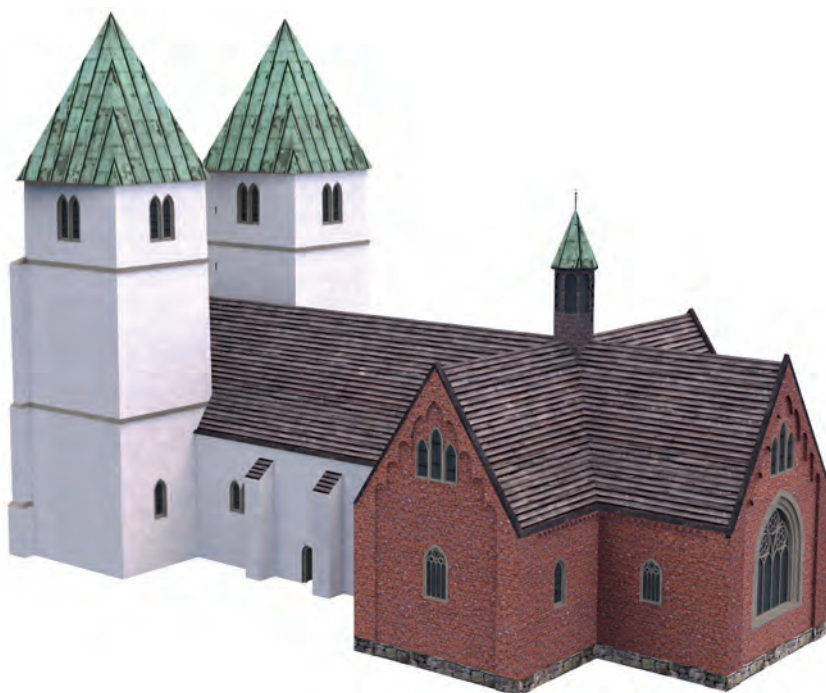
Fig. 30. Hypothetical reconstruction of St. Mary's c. 1300 with the extended west front and the new cruciform brick chancel. Model by Karen Maria Eiken-Engelgård after design by Stige and Snekkestad.

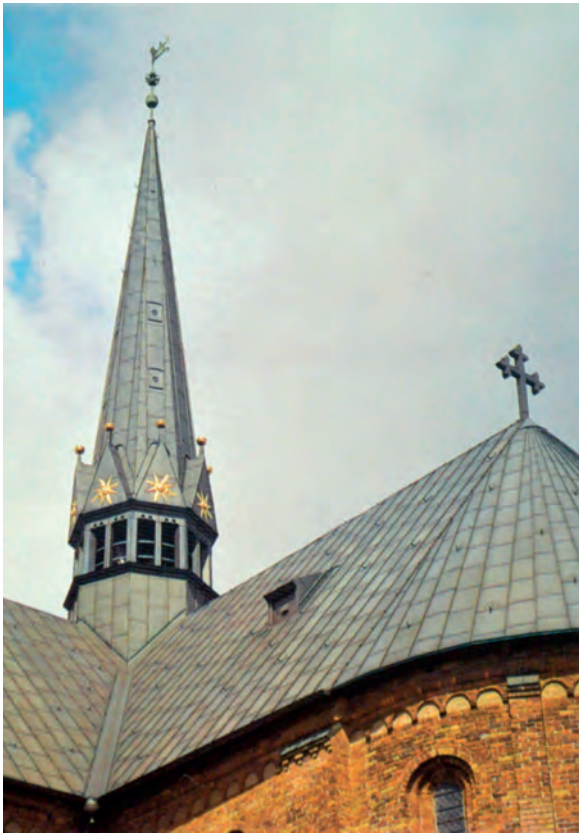
Fig. 31. The turret over the crossing at Roskilde Cathedral, Zealand. (After Kjersgaard: *Roskilde domkirke*. Roskilde, u.å.)

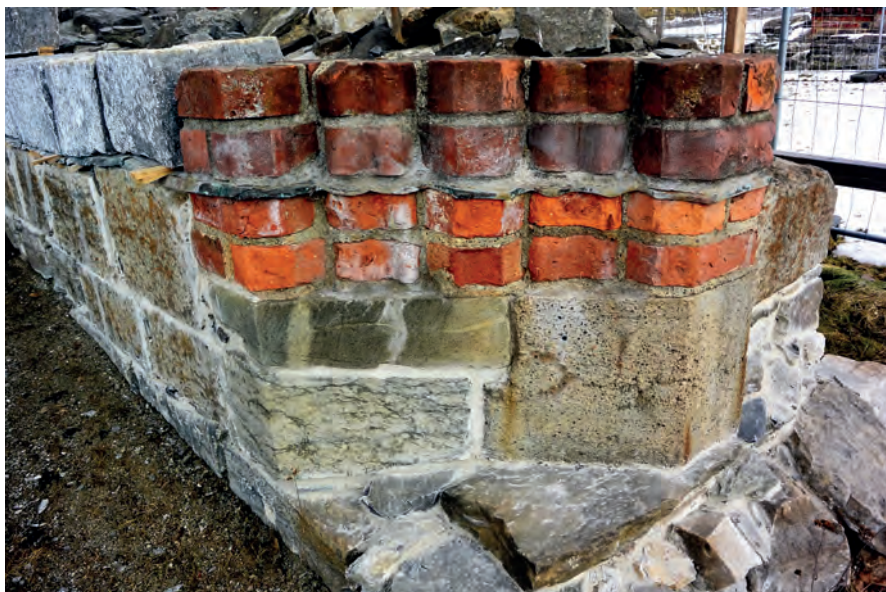
Fig. 32. The moulded splay of the west portal of the northern transept. Photo: Morten Stige.

The chancel had no monumental portal, only two modest doorways in the western corners and a secondary doorway in the north wall leading to the sacristy. The two lowest courses of the corner portals were in lime stone, and the rest of the framing in moulded brick. The mouldings are worn and difficult to interpret. A precise reconstruction of the profiles, based on the ruin and the brick fragments in the museum, would give valuable clues in the search for stylistic parallels. The opening of the southern portal is 109 cm wide, while the jambs of the north portal are lost.

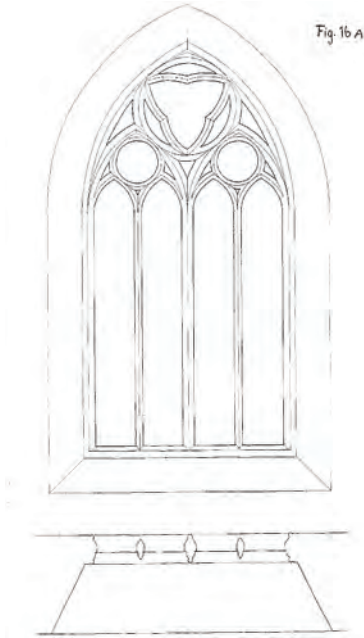
Fig. 33. Reconstruction of one of the stone tracery windows of St Mary's based on fragments found in the ruin by Randi Horgen and Håkon Christie. (After Horgen 1995: Fig. 16 A).

The windows constituted an important part of the architectural expression. Remnants of at least three different tracery windows and a number of lancet windows have been found in the ruin debris. They were discussed by Randi Horgen who worked closely with Håkon Christie. They were able to reconstruct the largest of

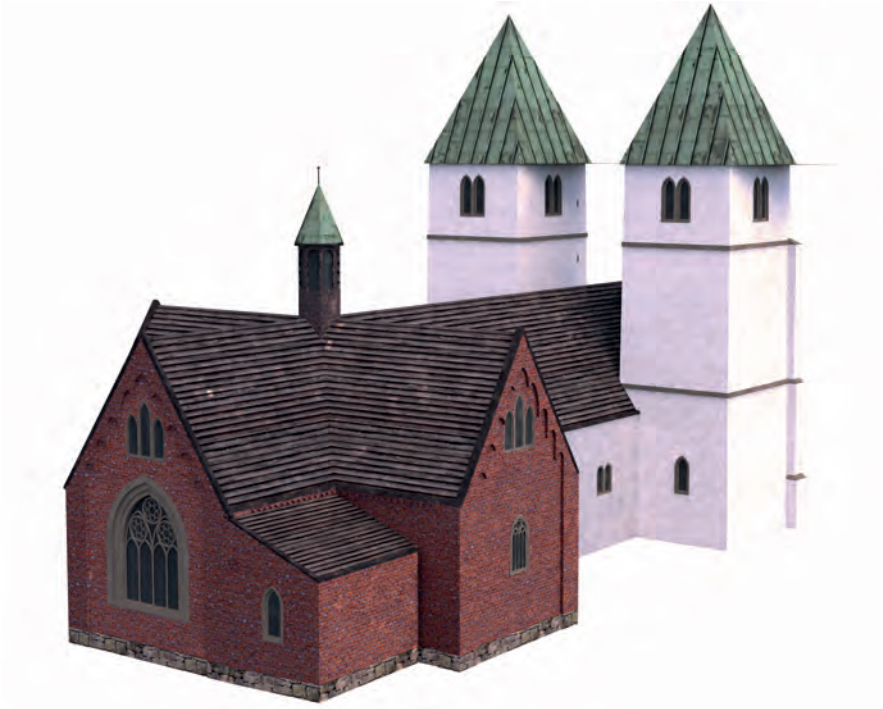
Fig. 34. Hypothetical reconstruction of St Mary's c. 1320 with the sacristy. Model by Karen Maria Eiken-Engelgård after design by Stige and Snekkestad.

The church had two secondary additions. Two walls running from the eastern extreme of the chancel to the middle of the northern transept made up a sacristy. While stylistically mimicking the chancel with brick over a stone masonry base, it lacks ash-lars and a strict linearity. Mentioned already in 1321, the sacristy was built not long after the new chancel was finished (DN V 66). Like in most other Nordic churches
