Medieval Oslo: A Case for the Defence

MICHAEL DERRICK

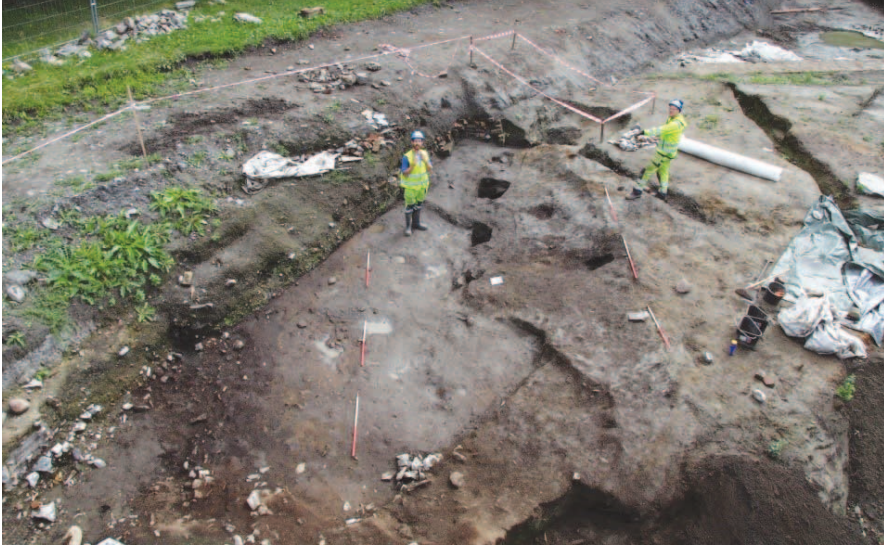
Figure 5. The top fills of the moat prior to excavation with archaeologists Erlend Nordlie (left) and Reidar Meyer (right). The 1 meter ranging rods in the centre of the photograph are positioned along the middle of the moat. The edge of the excavation area furthest to the left comprises a 1.60-meter-thick layer of soil which was laid down during landscaping of the area around 1799. Facing south-east. Photo: Michael Derrick NIKU.

In 2014, Schia's hypothesis was put to the test when areas immediately adjacent to his earlier excavation came under scrutiny as part of the Follo line project. The area was excavated in two stages, firstly in 2014–15 (Derrick 2018) and later in 2016 (Hegdal 2021). The two excavations uncovered the fragmented remains of a 20-meter-long section of moat (Figure 5 p. 11 and Figure 6 p. 12).

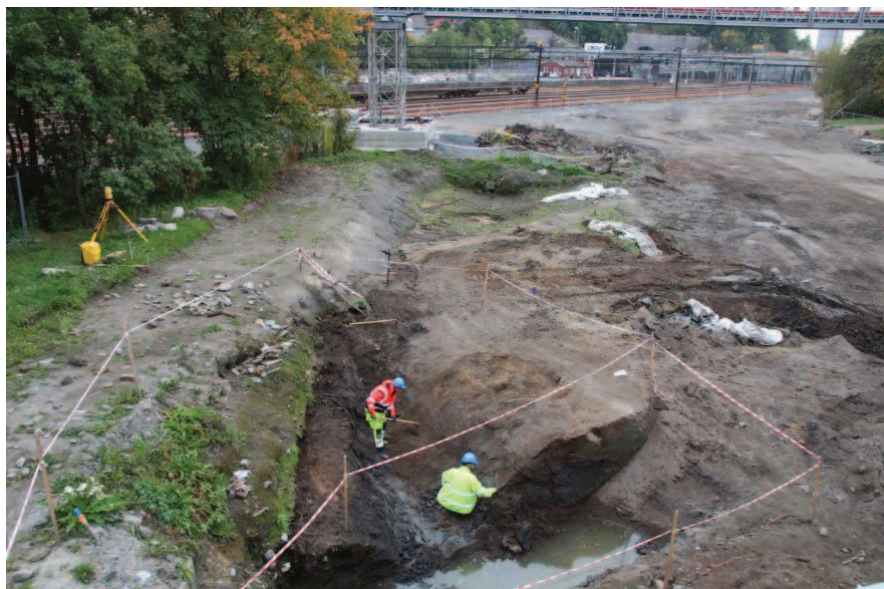
Above. Figure 6. Archaeologists Are S. Kolberg and Erlend Nordlie excavating the moat layer by layer. Facing south. Photo: Michael Derrick NIKU.

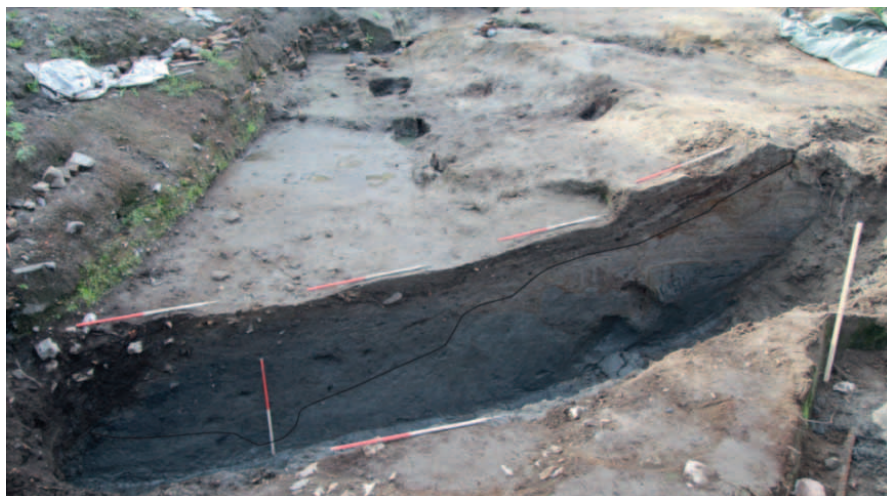
Figure 7. Previous page bottom: An east-west section through part of the moat excavated in 2015, Facing south. Photo: Michael Derrick NIKU. Top: The excavated moat in plan showing the location of the section drawings. Bottom: Combined Section drawings from the 2015 and 2016 which show a complete profile through the moat. The section drawing on the left (C3513) was excavated in 2016 and the section to the right (C13881) was dug in 2015. The thick black line represents the edge of the moat (Interpretation by Derrick). There are some variations in the layers between the two excavated sections. This is due not only to the distortion created when using an oblique profile but also because the sections lie 16 meters apart and include other locally backfilled layers. Section drawings: Tone Bergland and Michael Derrick NIKU.

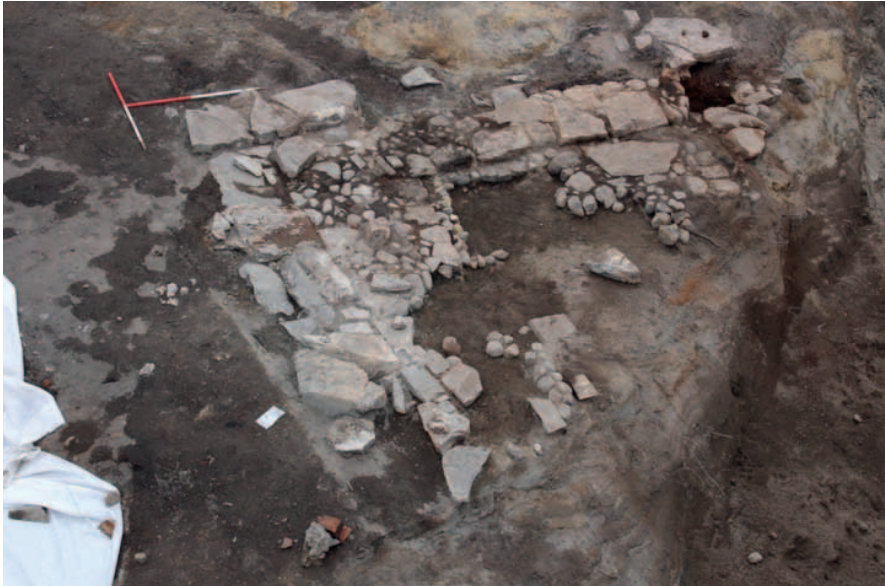
Figure 8. Stone cellar SA10 was reduced to a single course of stones and cobbled floor due to eighteenth-century levelling. The building was dated to the fourteenth century using stratigraphic relationships and ceramic dating. The building lay slightly over the edge of the moat. Facing south-east. Photo: Erlend Nordlie, NIKU.

The original height of the western side of the moat is slightly more difficult to ascertain as the only archaeological structure surviving in this area is stone building SA10 (Figure 8). As mentioned earlier, the remains of a construction cut indicated that the building lay partially underground. The building had an entrance on its east-

ern side. The level of the doorway lay at a height of 6.78 MASL and there were indications of a stairway. A similar stone building was found by archaeologist Cato Enger in the 1950's and later by Edman during the follo line excavations (forthcoming 2022). The stairway from this building was c. 1 meter higher than the floor within the building. If we add one meter to the entrance of the half-celled building it becomes apparent that the ground surface on the western side of the ditch could have lay at around 7.78 MASL – c. 70 cm lower than the eastern side. This fall in height from east to west likely reflects the natural fall in terrain towards Kongsgården. The lower level on the eastern side of the ditch could easily have been compensated with the construction of a high mound.

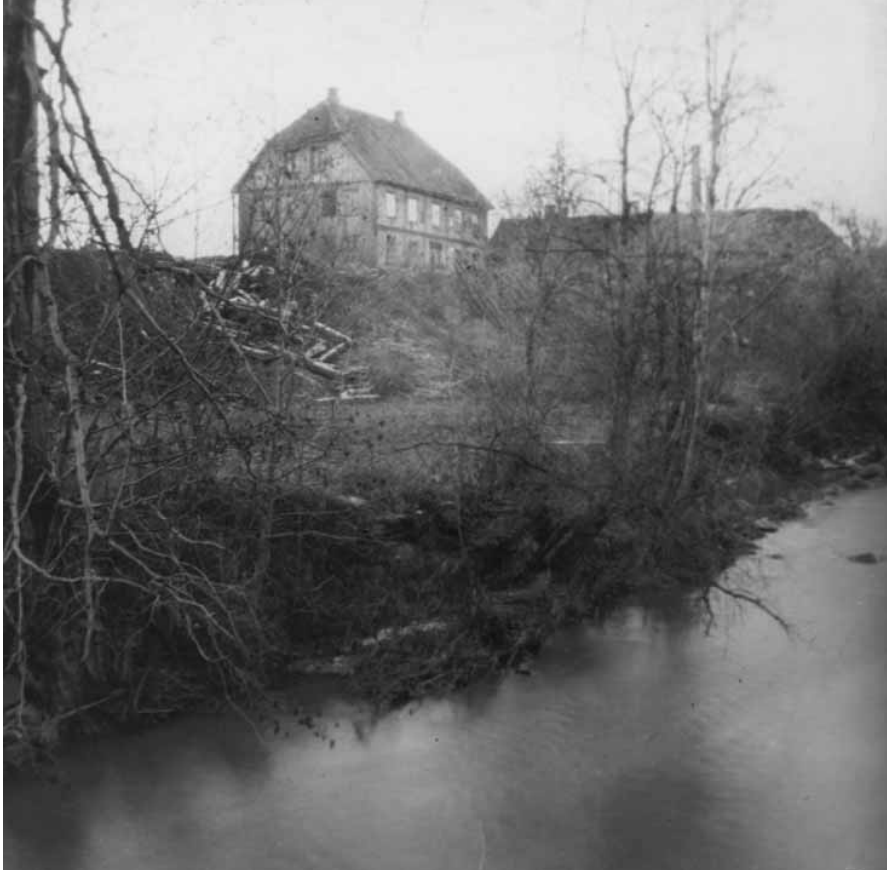
Figure 11. Saxegården seen from the banks of the Alna river 1905. Facing north-east. Photographer: Unknown. Oslo Museum, byhistorisk samling.

One of the problems with discussing the moat is that only a small 22-meter stretch of it survives. The reason for its survival is entirely down to its close proximity to Saxegården, which originally lay protected on an isthmus of land flanked on its southern side by the Alna river (Figure 11 p. 18). The coming of the railway obliterated the land surrounding Saxegården leaving the building (and part of the moat) stranded between two railway lines (Figure 12 p. 19). The moat fragment is the only evidence we have for any structures which could relate to defensive activity outside the walls of Kongsgården. In order to locate the rest of the moat it is important to understand its connection to Kongsgården and the events that have occurred since its abandonment.

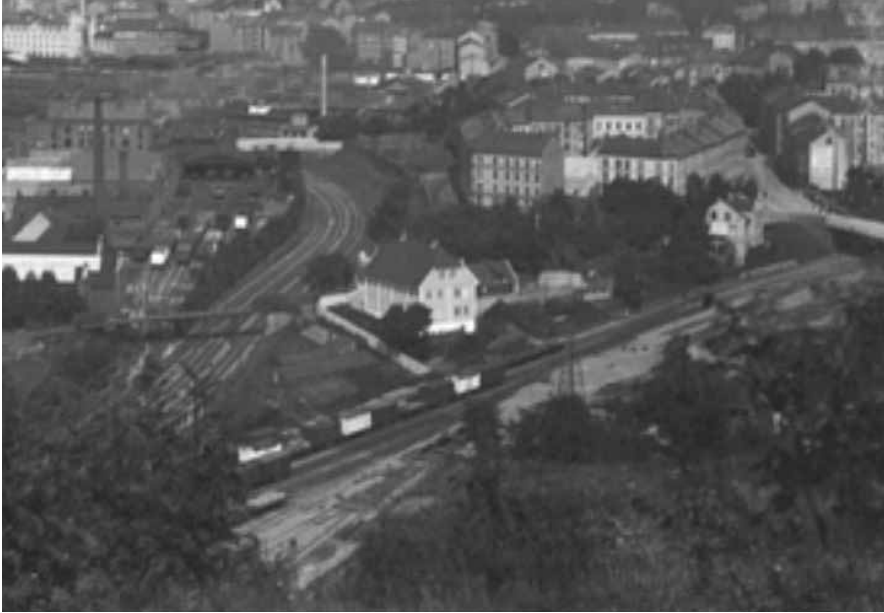
Figure 12. Saxegården (centre) photographed 1910–20, as seen from the south. The building lies between two railway lines. The line at the bottom of the photograph was placed along the original footprint of the Alna river which was rerouted underground in 1905. Photographer: Unknown. Oslo Museum, byhistorisk samling.

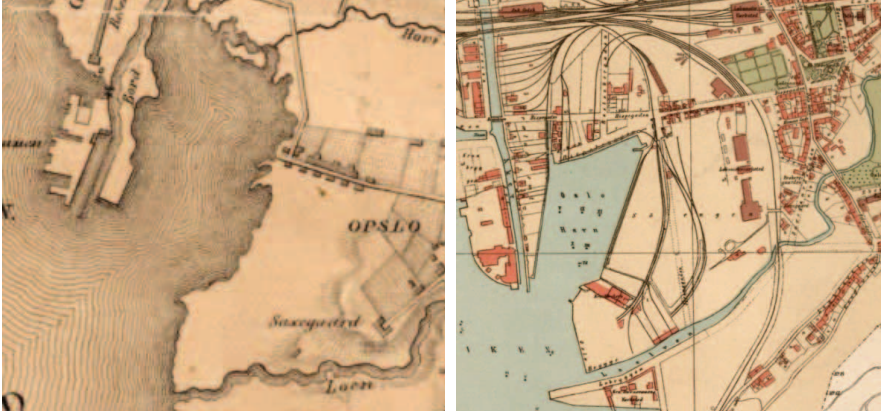
Figure 14. Carl B. Roosen's map 'Christiania med nærmeste omgivelser' 1830 (left) and 'Kart over Kristiania af Byens Opmaalingsvæsen' 1901 (right). The impact of the railway is evident in the map from 1901 which shows the tracks cutting across the heart of the medieval town. Reproduced with the permission of Kartverket (Norges Geografiske Oppmåling).

is evident when comparing the 1830 and 1901 maps of the area. These show the landscape changing from pastoral to industrial in the space of 70 years (Figure 14).

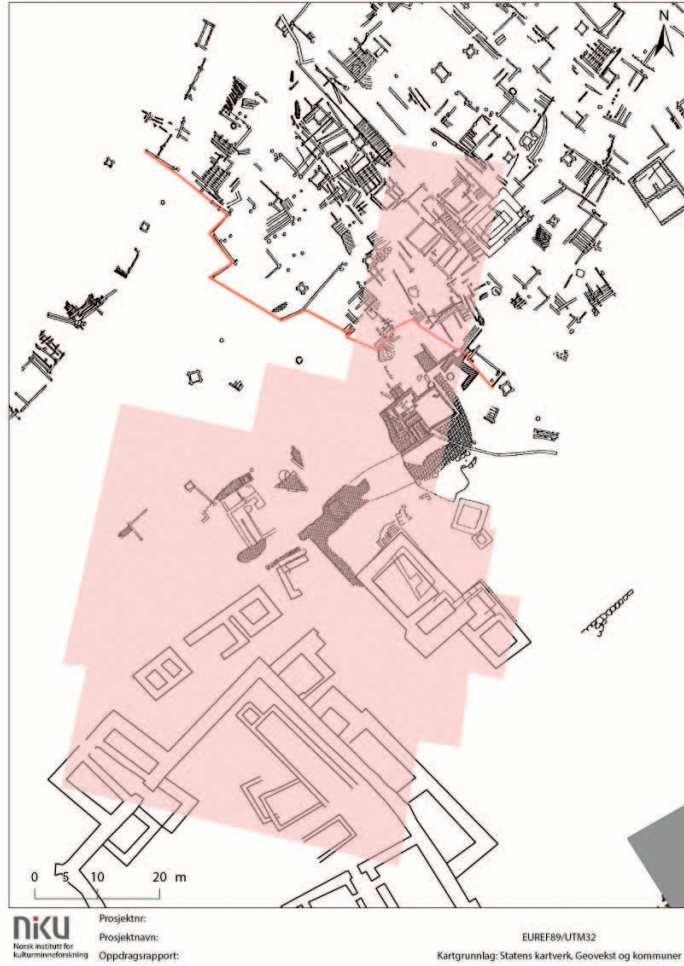
Figure 15. A map showing the area documented by Meyer before the construction of the new locomotive workshop (shaded pink). The northern part of his area is occupied by tightly packed wooden buildings representing settlement activity while the southern area close to Kongsgården is relatively free of such activity. The red line demarcates the edge of the main settlement. Illustration: Michael Derrick NIKU.

While there is no direct archaeological evidence for the continuation of the moat, there remains some compelling indirect evidence that could suggest its presence in the landscape. As mentioned above, the moat fragment appears to turn towards the west. If it continued in this direction it would pass Kongsgården's northern façade continuing towards Oslo fjord where it would terminate and join with the sea. The suggested path of the moat would cut through an area excavated by Meyer in the 1890's, prior to the building of a second locomotive workshop. Figure 15 shows the

footprint of this part of his excavation together with the structures uncovered close to Kongsgården's northern façade. Towards the north of the excavation area, laid a series of tightly packed wooden buildings and passages, representing the southern extent of settlement activity within the town. The red line shown in Figure 15 defines this extent. It is apparent that building activity thins out towards the south and disappears completely to be replaced by a series of stone buildings and streets close to the Kongsgården's walls.

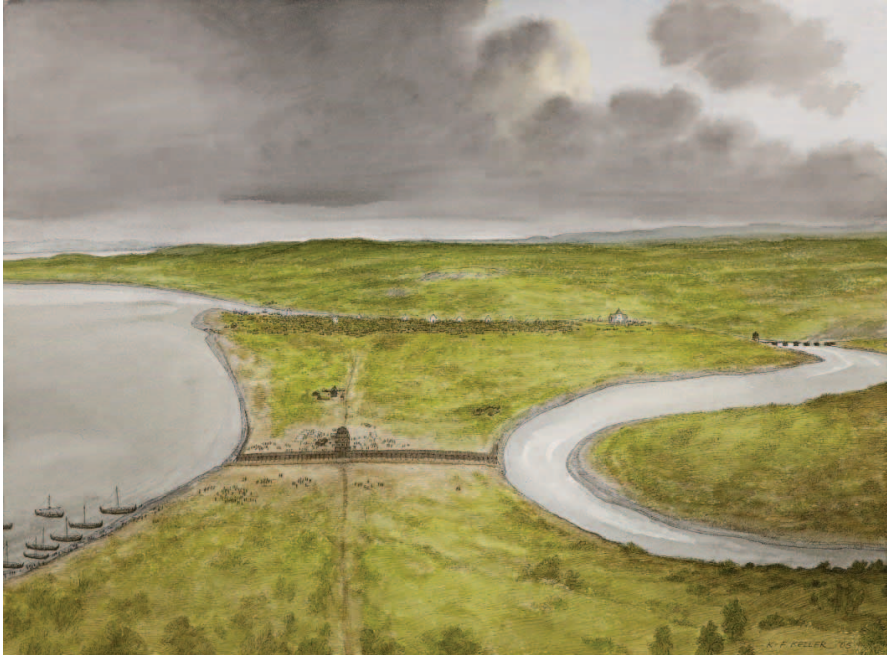
Figure 17. A reconstruction drawing of Treborgen at Ilevollene in Trondheim built around 1178–79 by Archbishop Øystein Erlendsson. A moat together with a mound and palisades cut across the mainland connecting the river Nidelva and the fjord, protecting the town from attack. Illustration: Karl Fredrik Keller (2008).

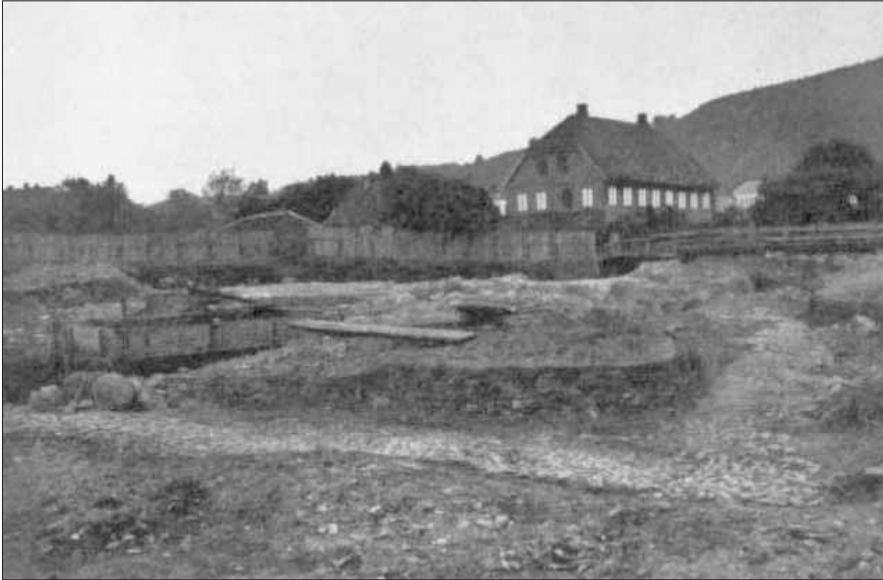
Figure 20. The two stone streets uncovered by Meyer in 1892 together with a series of stone buildings. Both the streets and buildings are likely to post-date the moat which would have lain underneath. The street closest to the camera was later interpreted as Vestre Strete, one of Oslo's most important thoroughfares linking Kongsgården to the bishop's castle. The prominent building at the top of the picture is Saxegården, the location of the moat excavations. Facing south-east. Photographer: Meyer 1892 (Fischer 1950).
